**MARINE INVESTIGATION REPORT**  
**M01L0112**

**MAJOR WATER INGRESS**

**SCALLOP DRAGGER *ALEX B. 1***

**29 SEPTEMBER 2001**

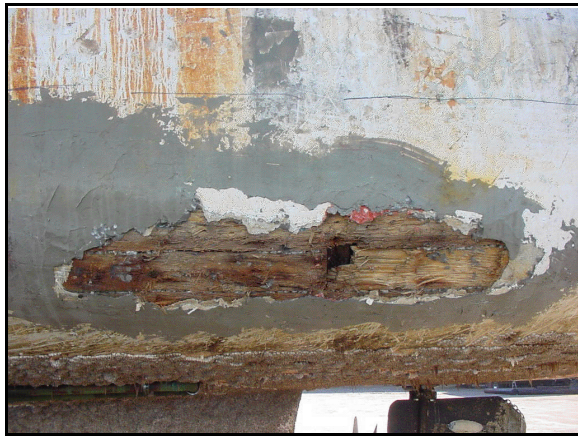
On both sides of the hull below the waterline in way of the lazarette, the fibreglass coating on the wood hull was severely damaged. Gaps in the fibreglass coating on each side were about 125 cm long and 50 cm wide, exposing the underlying wood. The wood planking showed deep scrape marks, indicating wear likely caused by repeated contact with the drag and steel cables on the hull. There was a hole, measuring approximately 10 cm in diameter, in the wood planking on the port side.

**Photograph 2.** Damage, port side

Examination of the vessel revealed substantial wear on the hull in way of the lazarette. These patches of excessive wear are in way of the drag hoist pulleys that were mounted on the stern A-frame. The fibreglass coating was worn through and there were deep gouges in the wood planking. The scallop drag on the *Alex B. 1* is a conventional fishing rig, quite heavy and cumbersome to handle. The drag was hoisted aboard and redeployed twice every hour. Consequently, every time the rig was hoisted aboard or deployed, it came in contact with the hull. To protect against the resultant abrasion, protection is applied to the hulls of fishing vessels where the fishing gear touches the hull. Various types of protection are used: on steel hulls, steel or rubber half-rounds are installed; wooden hulls are protected by a second layer of planking, a thick coating of fibreglass, or pads made of teflon or rubber. All of these protective devices have proved effective for shielding the hull against repeated contact with the fishing gear. Apart from a thin coating of fibreglass that completely covered the hull, the *Alex B. 1* had no additional protection in way of the lazarette. In five months of fishing activity, the hull had been compromised to the extent that the integrity of the vessel and the safety of the crew were greatly diminished.

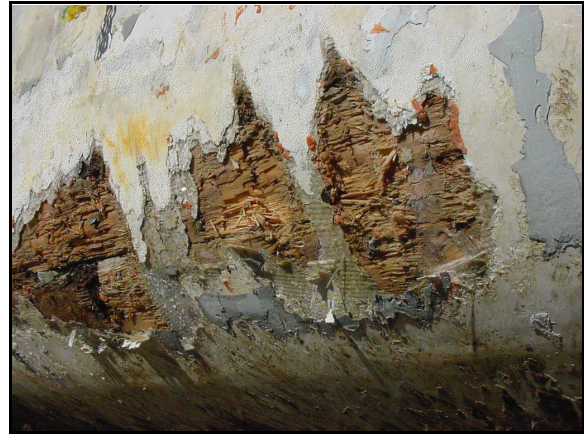
**Photograph 3.** Damage, starboard side
